***In-situ* SEM study of fatigue micro-crack initiation and propagation behavior in pre-corroded AA7075-T7651**

Fatigue micro-cracking behavior in pre-corroded AA7075-T7651 is analyzed by *in-situ* scanning electron microscopy (SEM) observation and SEM-based fractography. The experimental results show that (i) fatigue micro-cracks nucleated mainly from inclusions at the specimen notch and from corrosion pits on the specimen surface, (ii) pre-corrosion severity degree and maximum stress level significantly affected the extent and time of micro-crack initiation. Corrosion pits are shown to play a crucial role in fatigue micro-crack propagation, due to crack deflection (light corrosion) and crack coalescence (severe corrosion). The growth rate of minor cracks was suppressed by pre-dominant rapid propagation of the main crack.

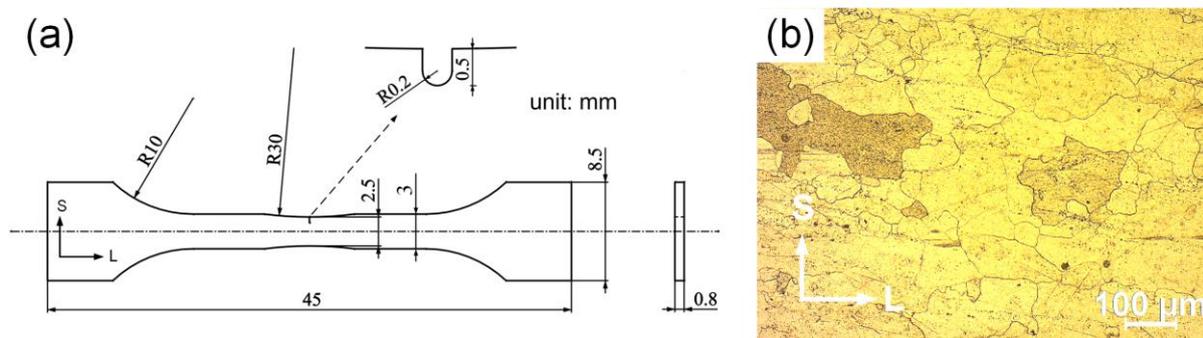
Fig. 1. (a) Schematic diagram of specimen, (b) microstructure of AA7075-T7651 along the L-S direction.

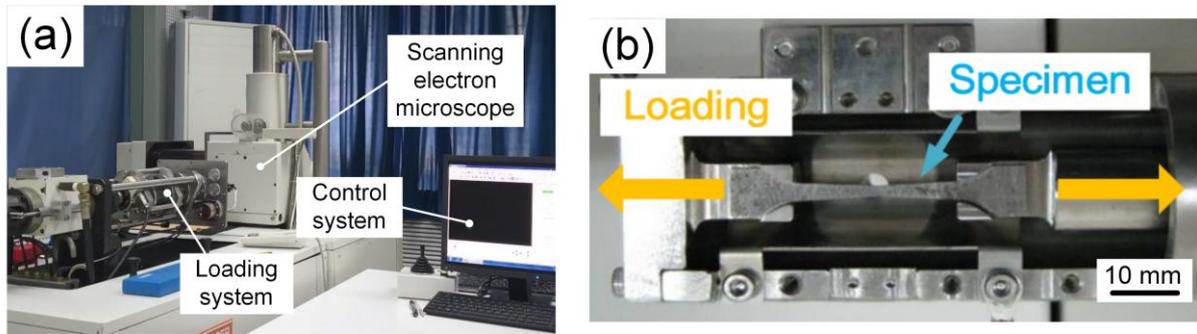
Fig. 2. (a) Experimental apparatus for *in-situ* SEM fatigue tests, (b) applied fatigue stress waveforms.

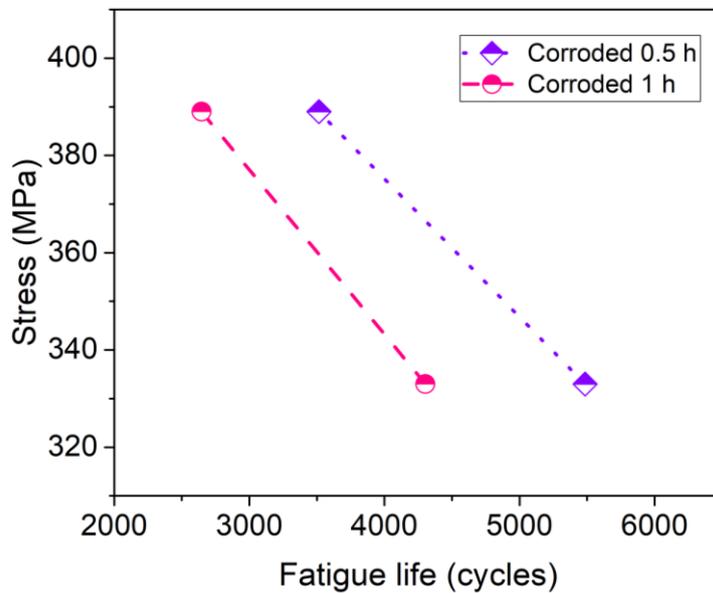
Fig. 3. Measured fatigue lives of pre-corroded AA7075-T7651 under different experimental conditions.

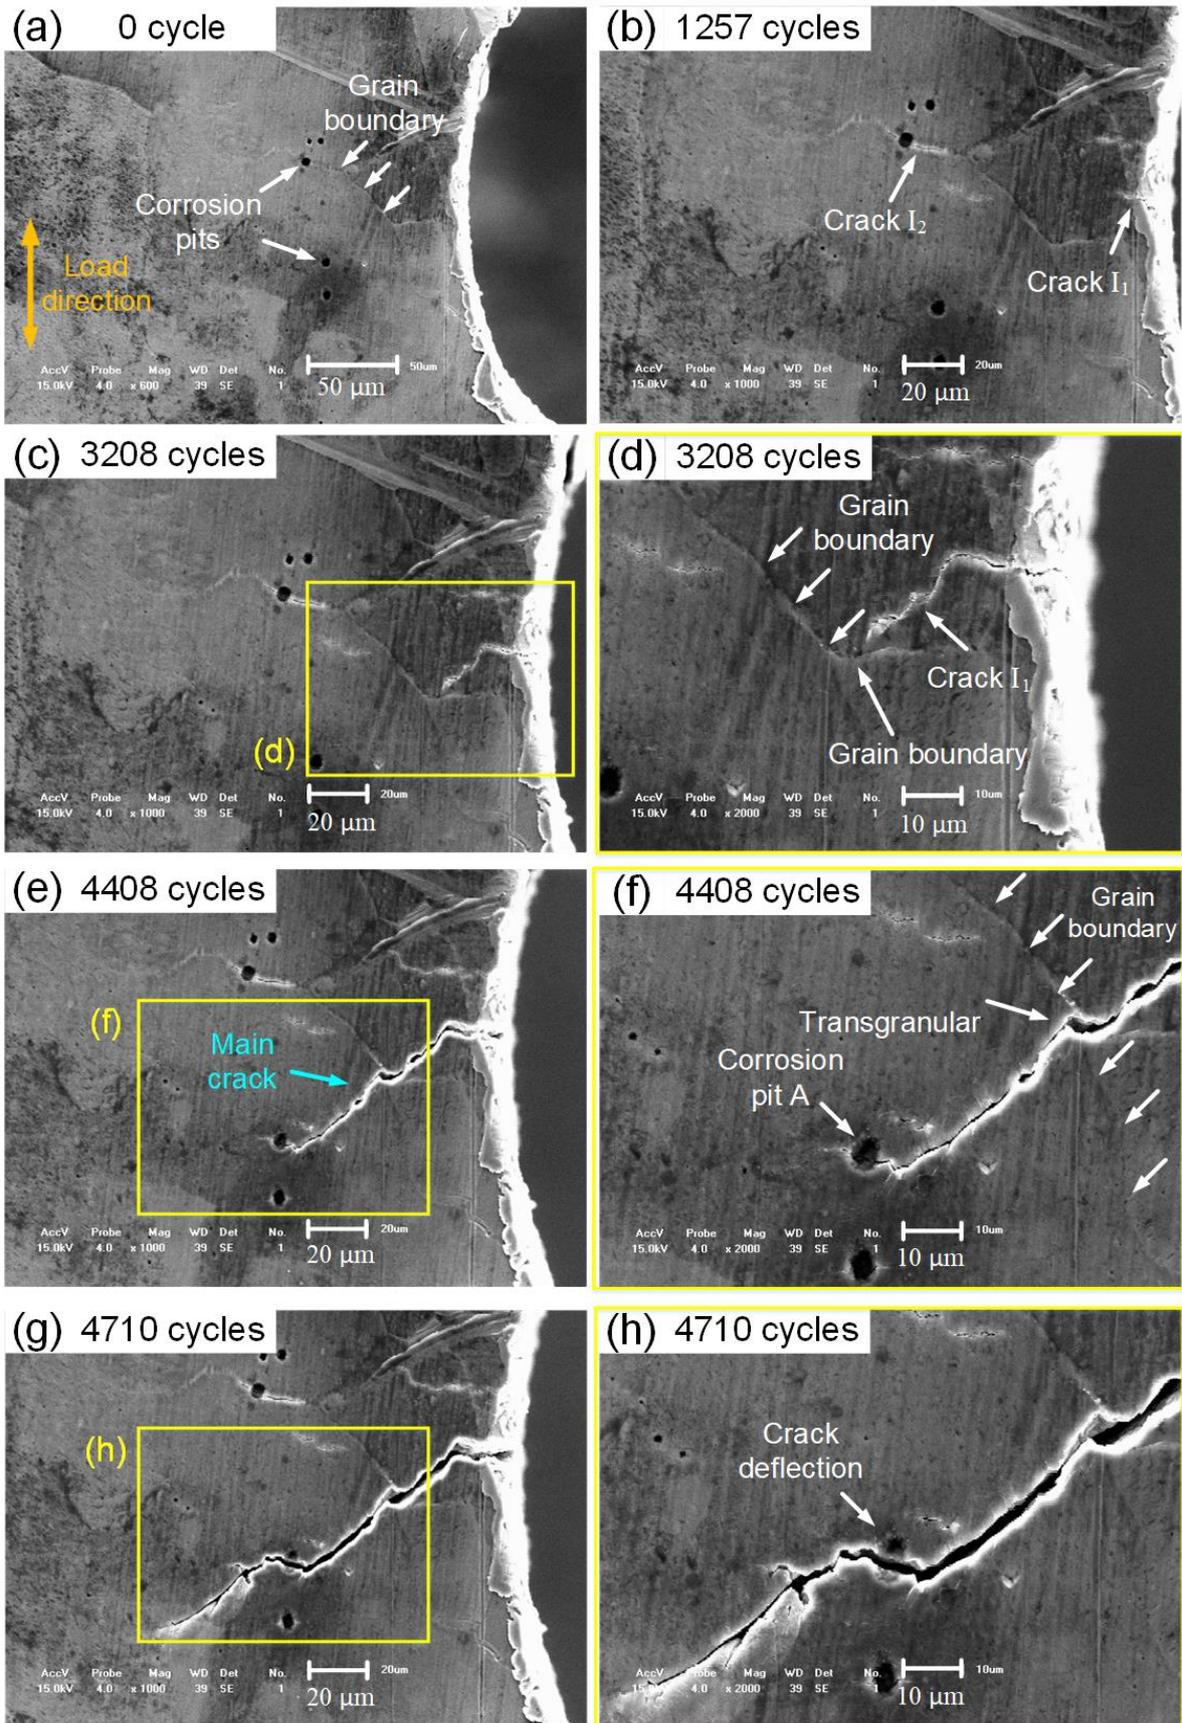
Fig. 4. *In-situ* SEM observation of fatigue failure process of specimen with a corrosion time of 0.5 hour, at a stress level of $\sigma_{\max} = 333$ MPa; the yellow squares are the field of view of subsequent images.

Experimental observation illustrates that corrosion pits play a crucial role in the propagation of fatigue crack. For pre-corrosion of 0.5 hours, corrosion pits had an influence on propagation direction of the main crack. As shown in Fig. 4 (g), main crack I₁ deviated from the original path and turned towards the corrosion pit. However, due to limited numbers and size of corrosion pits, only pits near the crack-tip affected crack propagation; pits remote from the crack-tip had little effect on crack propagation path. For 1-hour pre-corrosion, micro-cracks were originated from a cluster of corrosion pits and interconnected with adjacent ones into a larger crack, thus affecting the main crack path due to crack coalescence, despite being remote from the main crack-tip, as illustrated in Fig. 6. Experimental observation also showed that the fatigue micro-crack propagation direction and path are affected by material microstructural features, such as grain boundaries, near the crack tip, especially in some regions without obvious corrosion damage, as shown in Fig. 5; both transgranular and intergranular fracture modes were simultaneously observed, reflecting competitive relationships between grain boundary bonding force and grain strength. Generally, when the angle between grain boundary and original crack direction is small, intergranular fracture occurs more easily.

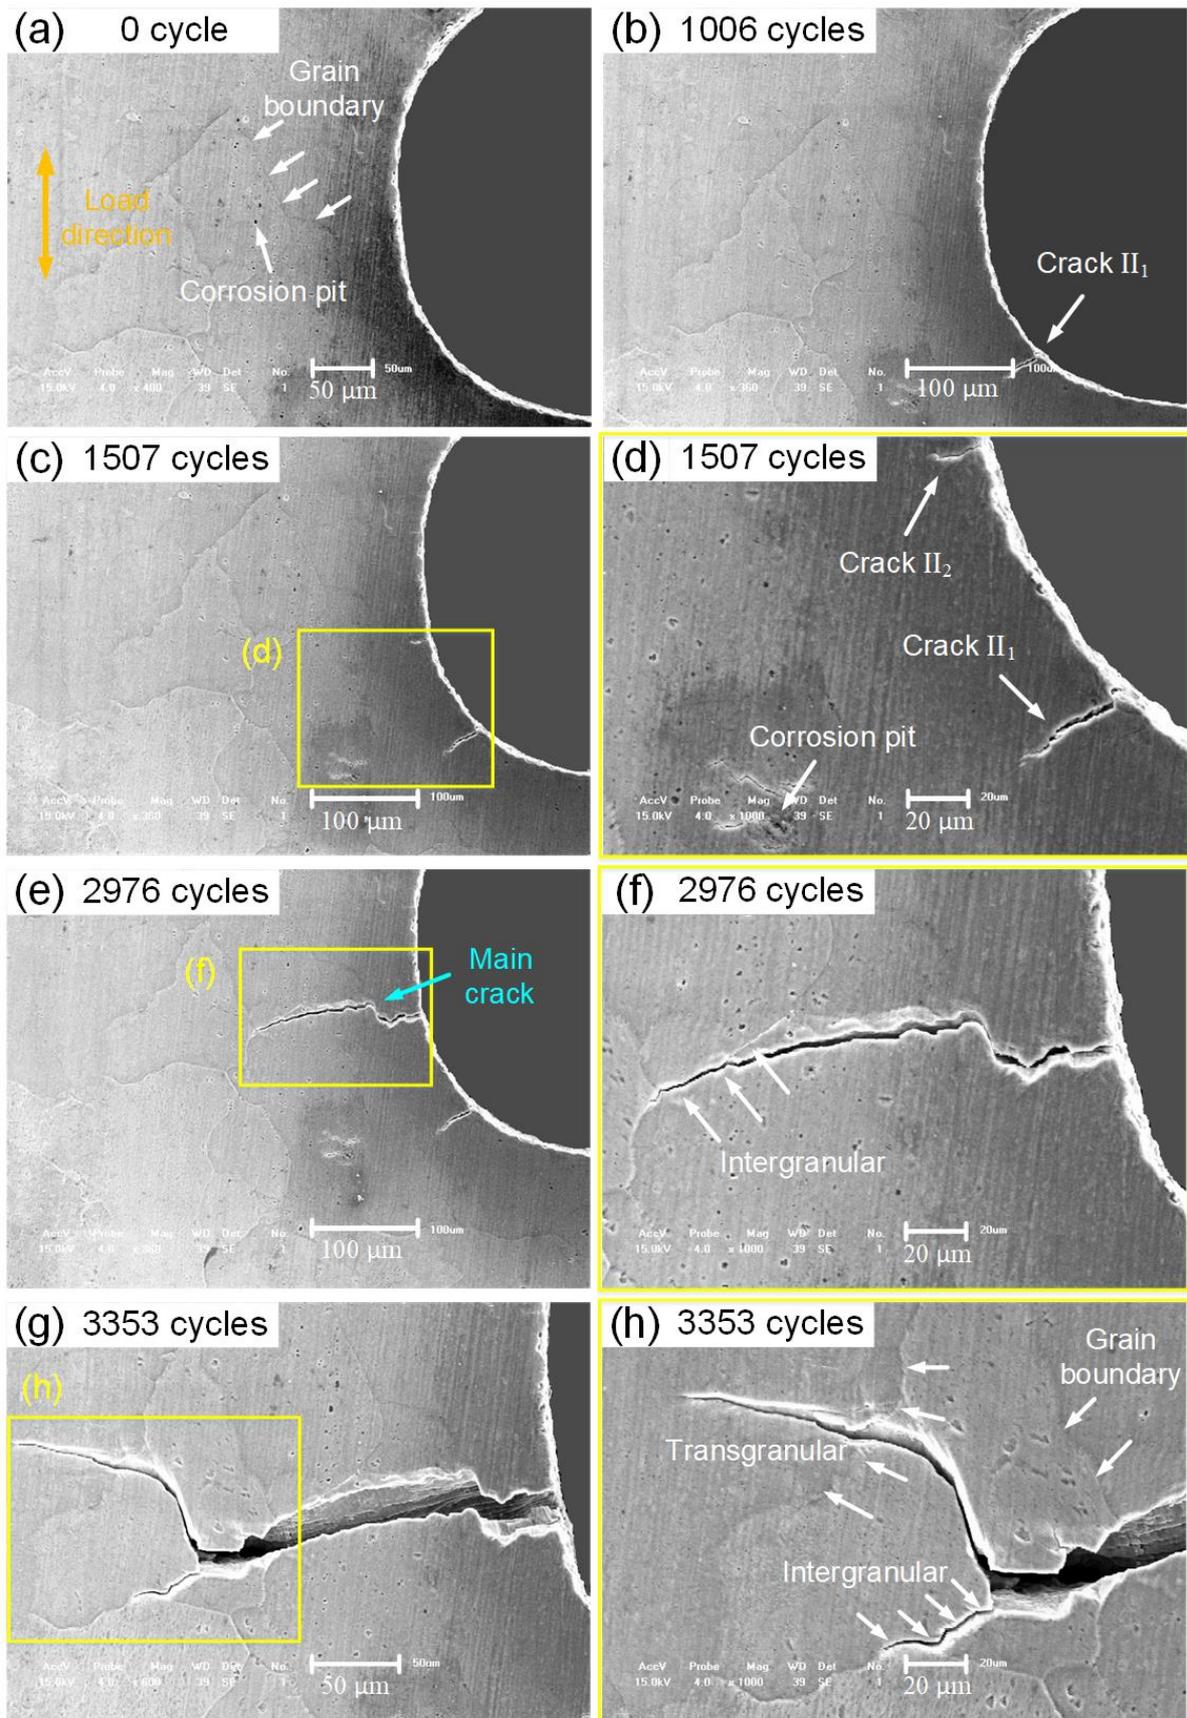
Fig. 5. *In-situ* SEM observation of fatigue failure process of specimen with a corrosion time of 0.5 hour, at a stress level of $\sigma_{\text{max}} = 389 \text{ MPa}$; the yellow squares are the field of view of subsequent images.

Micro-crack arrest effects were also observed in the multiple crack propagation phenomena, attributed to decrease in driving force of crack propagation due to stress release caused by propagation of other cracks. The first crack initiated did not necessarily lead to final fracture. As shown in Fig. 5, crack II₁ arrested after initiation of main crack II₂, indicating that propagation of the main crack had an inhibiting effect on secondary crack propagation. The lengths of main and secondary cracks for specimens under different experimental conditions were plotted versus numbers of fatigue cycles in Fig. 12, thus demonstrating that decreased propagation rate or arrest of secondary cracks after main crack initiation.

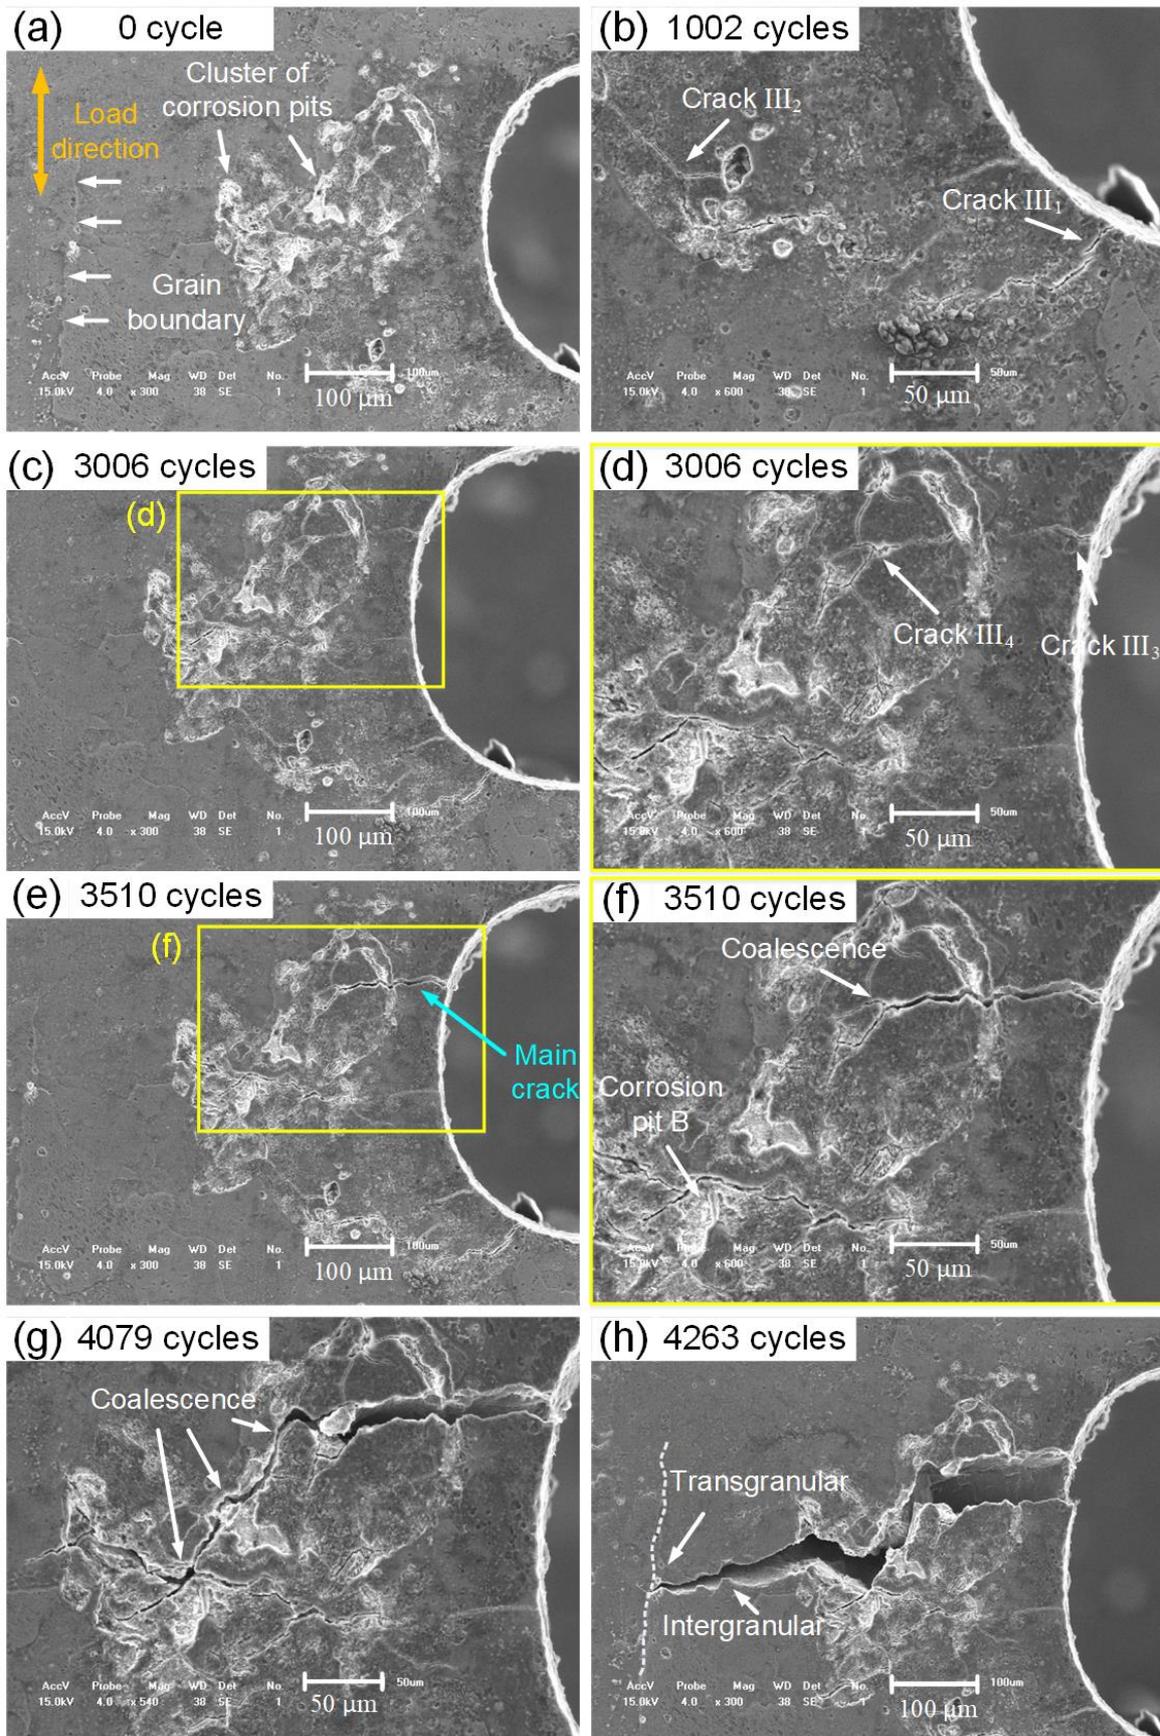
Fig. 6. *In-situ* SEM observation of fatigue failure process of specimen with a corrosion time of 1 hour, at a stress level of $\sigma_{\max} = 333$ MPa; the yellow squares are the field of view of subsequent images.

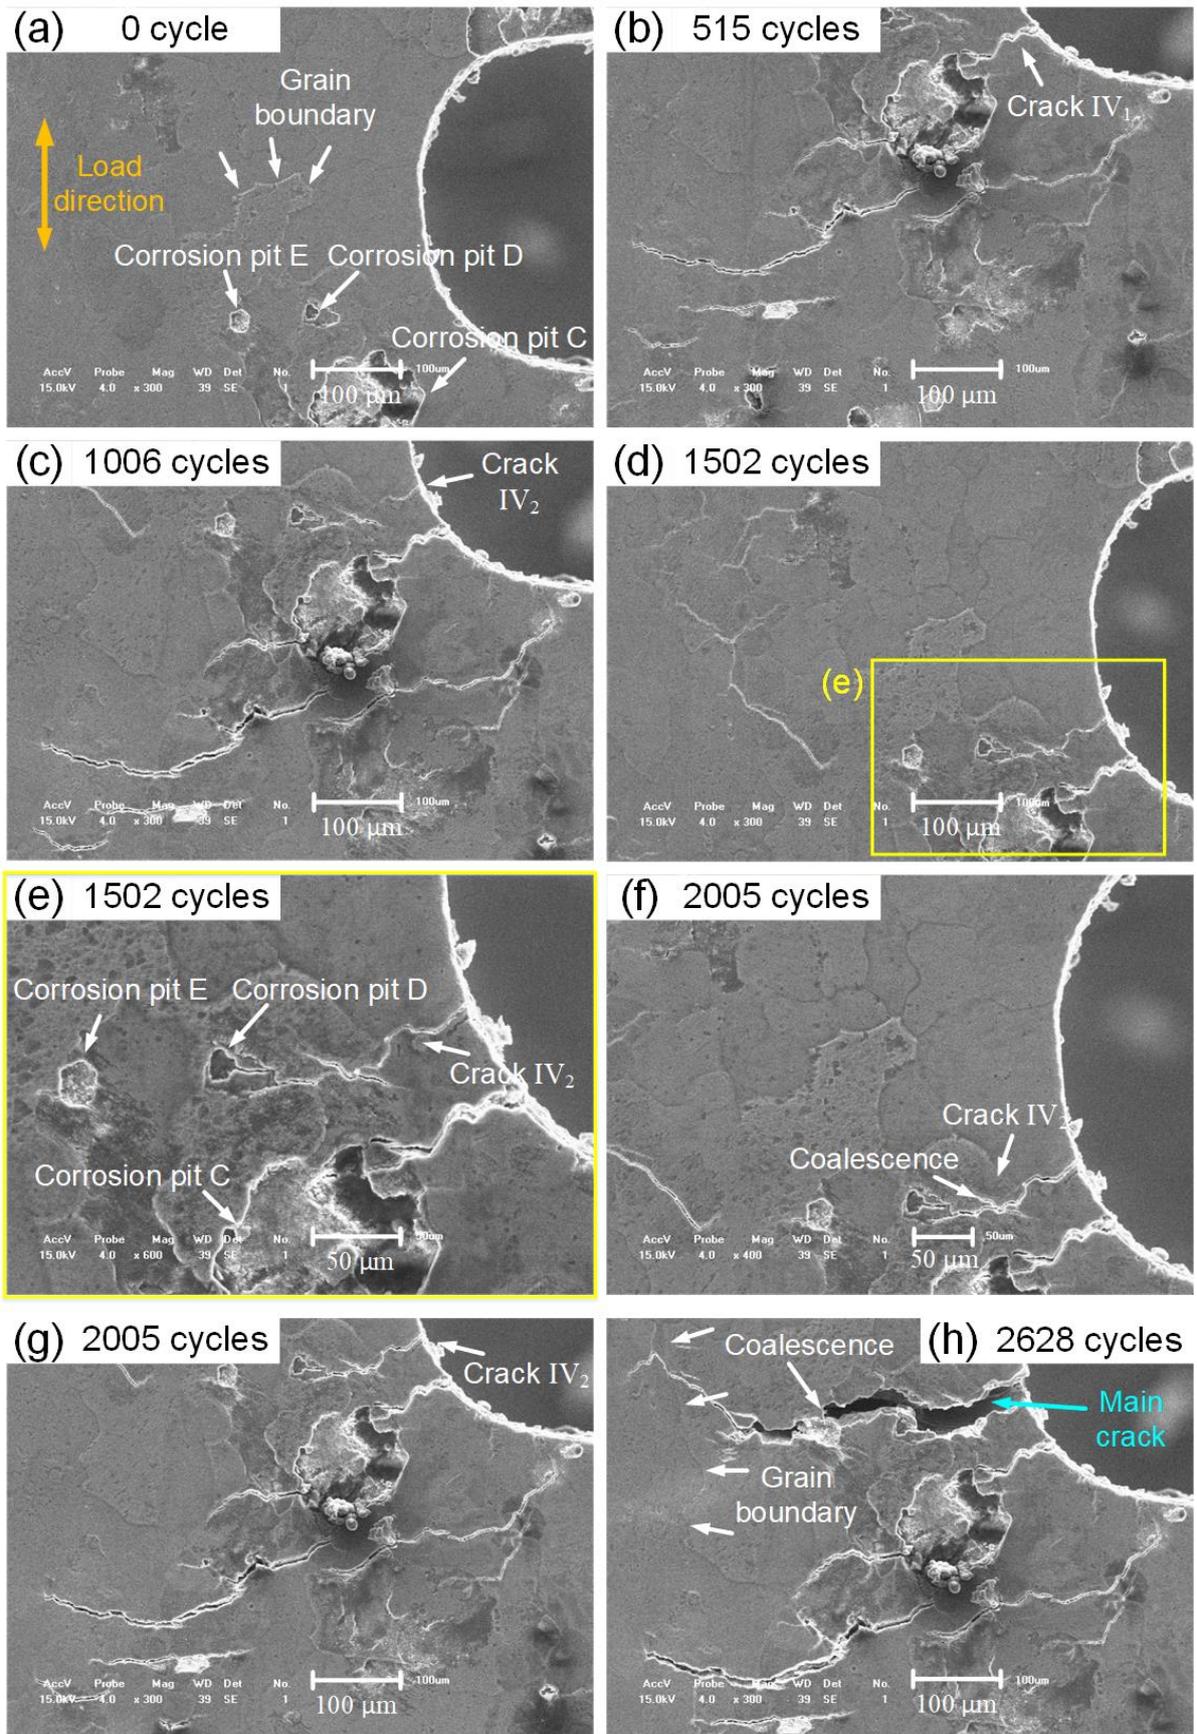
Fig. 7. *In-situ* SEM observation of fatigue failure process of specimen with a corrosion time of 1 hour, at a stress level of $\sigma_{\max} = 389$ MPa; the yellow squares are the field of view of subsequent images.

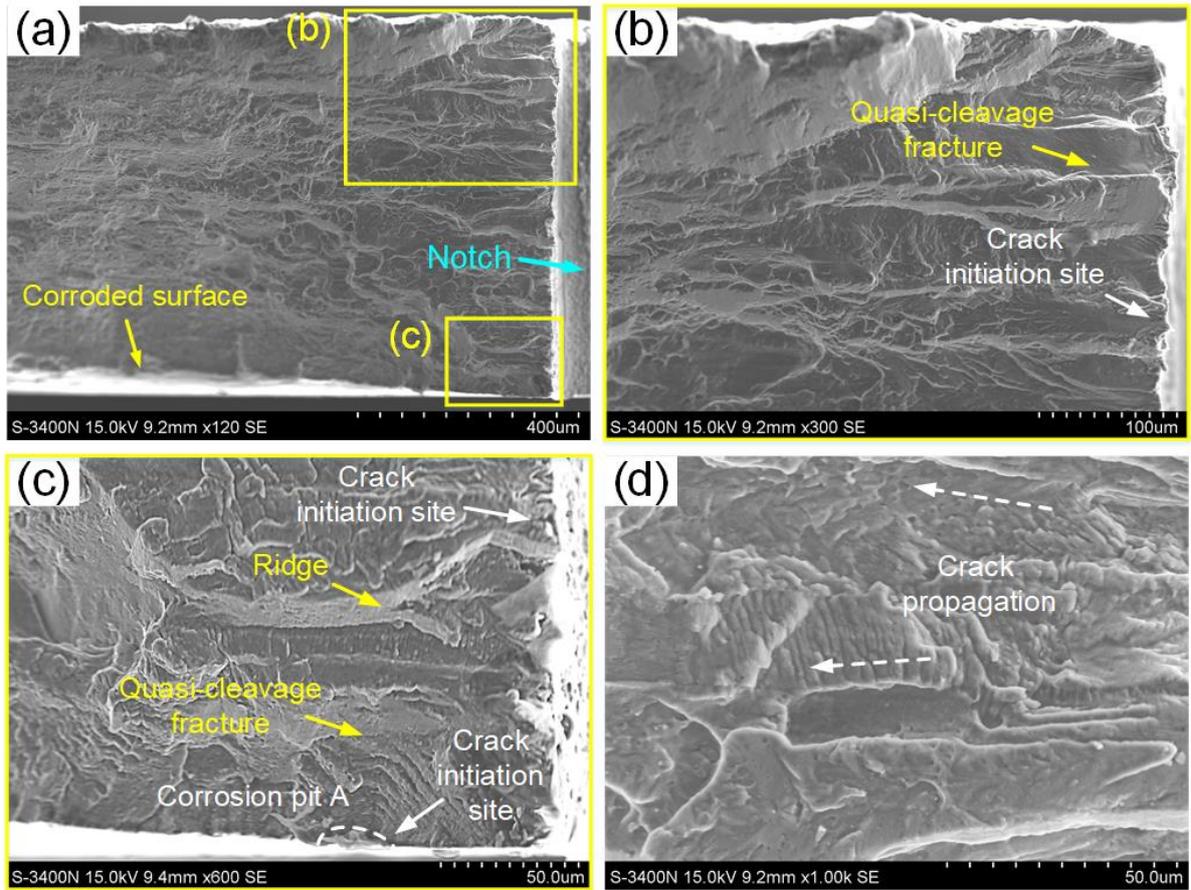
Fig. 8. Fracture morphology of specimen with a corrosion time of 0.5 hour, at a stress level of $\sigma_{\max} = 333$ MPa, corresponding to the specimen shown in Fig. 4; the yellow squares are the field of view of subsequent images.

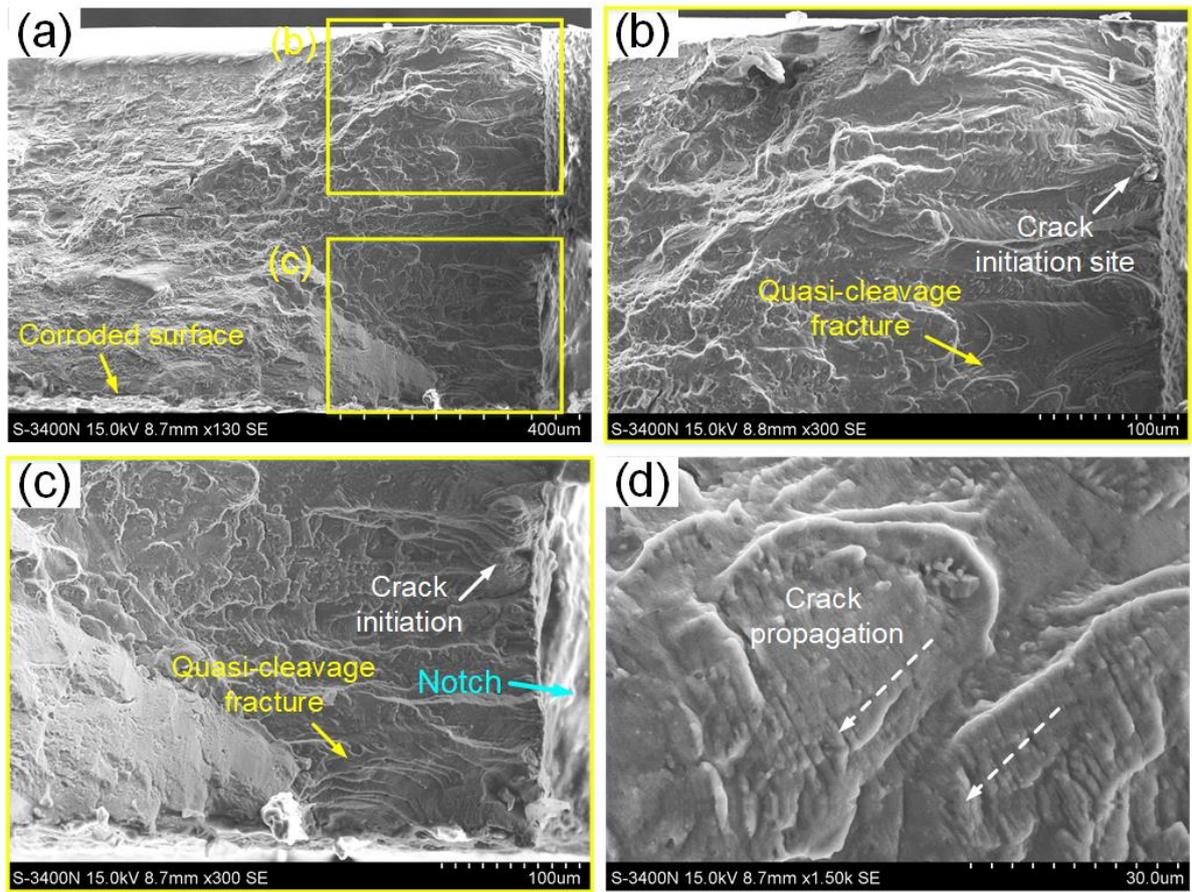
Fig. 9. Fracture morphology of specimen with a corrosion time of 0.5 hour, at a stress level of $\sigma_{\max} = 389$ MPa, corresponding to the specimen shown in Fig. 5; the yellow squares are the field of view of subsequent images.

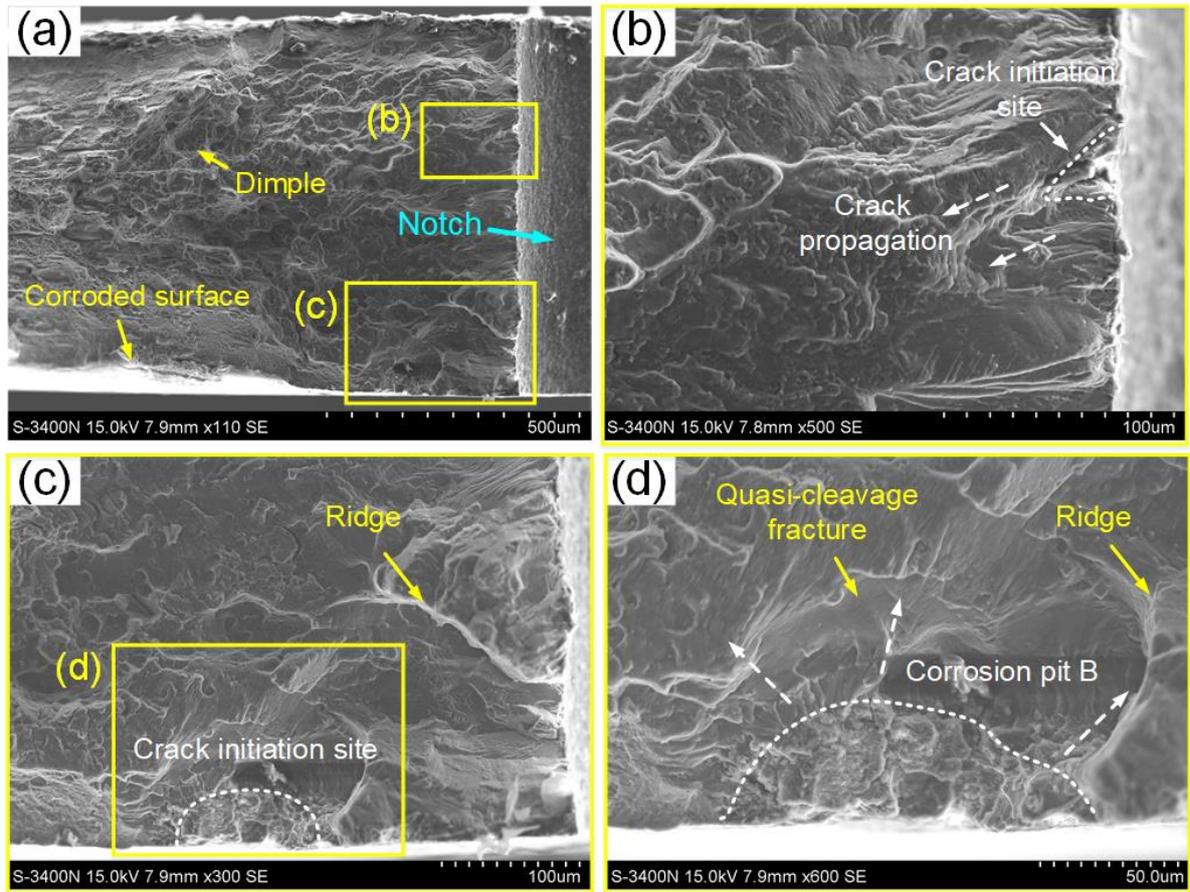
Fig. 10. Fracture morphology of specimen with a corrosion time of 1 hour, at a stress level of $\sigma_{\max} = 333$ MPa, corresponding to the specimen shown in Fig. 6; the yellow squares are the field of view of subsequent images.

Fig. 10 illustrates the fracture morphology for a corrosion time of 1 hour and stress level $\sigma_{max} = 333$ MPa, corresponding to the *in-situ* SEM observation of Fig.6. Again, multiple sites of crack initiation are observed in the notch (Figs. 10 (a), (b) and (c)). From the enlarged view, it can be seen that the main crack initiated at an inclusion located in the notch. A corrosion pit was found to cause micro-crack initiation at the corroded surface, as shown in Fig. 10 (c) and the enlarged view Fig. 10 (d); this corresponds to corrosion pit B of Figs. 6 (e) and (f). The corrosion pit is larger than for the 0.5 hour case shown in Fig. 8 (c). Ridges were also formed due to the propagation and coalescence of adjacent micro-cracks (Fig. 10 (c) and (d)). The fracture surface consists of other features such as dimples and quasi-cleavage fracture, as shown in Figs. 10 (a) and (d). Fig. 11 showed the fracture morphology for I hour corrosion time and $\sigma_{max} = 389$ MPa, for *in-situ* SEM observation of Fig. 7. Multiple fatigue crack initiation sites were again observed in Fig. 11 (a), (b) and (c). From the enlarged view shown in Fig.11 (b), it was found that a corrosion pit located at the corroded surface promoted crack initiation and the resulting micro-crack nucleated from the notch coalesced with a micro-crack initiated from corrosion pit D to create a ridge. The ridge was also found to coalesce with adjacent micro-cracks located in the notch (Fig.11 (c)). The propagation path of the main crack across the corrosion pit on the specimen corroded surface as shown in Fig.11 (d).

Multiple micro-cracks were observed to originate from inclusions located in the notch (Fig. 10 (b)), and from corrosion pits on the specimen surface (Fig. 10 (d)). For a corrosion time of 0.5 hour, corrosion pits on the surface were fewer, smaller ($d < 10\mu m$), and relatively isolated, giving reduced micro-crack initiation and absence of crack coalescence, as shown in Fig. 4. In contrast, for a corrosion time of 1 hour, a cluster of corrosion pits promoted increased micro-crack initiation and coalescence during fatigue, as shown in Fig. 6. Specifically, for the 0.5 hour corrosion case, only about 4 micro-cracks initiated under both stress levels ($\sigma_{max} =$

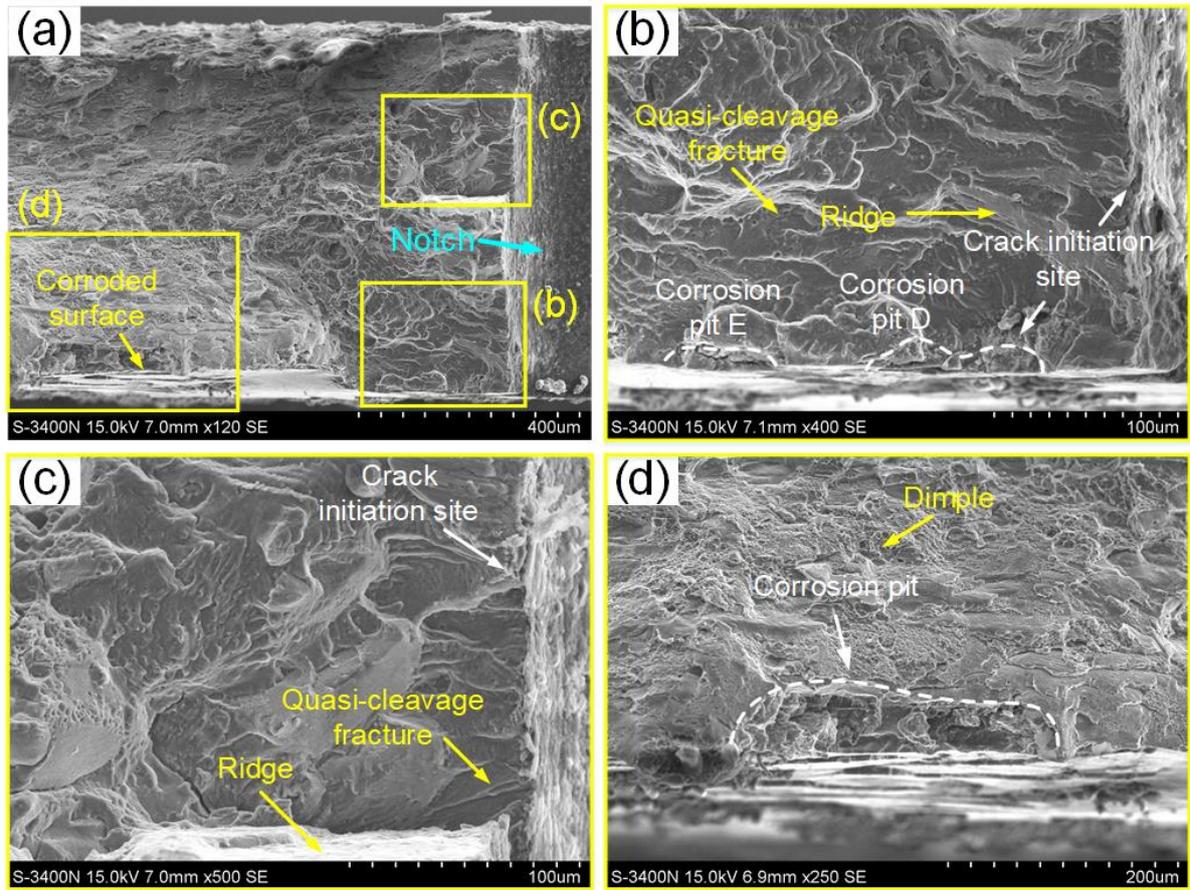
Fig. 11. Fracture morphology of specimen with a corrosion time of 1 hour, at a stress level of $\sigma_{\max} = 389$ MPa, corresponding to the specimen shown in Fig. 7; the yellow squares are the field of view of subsequent images.

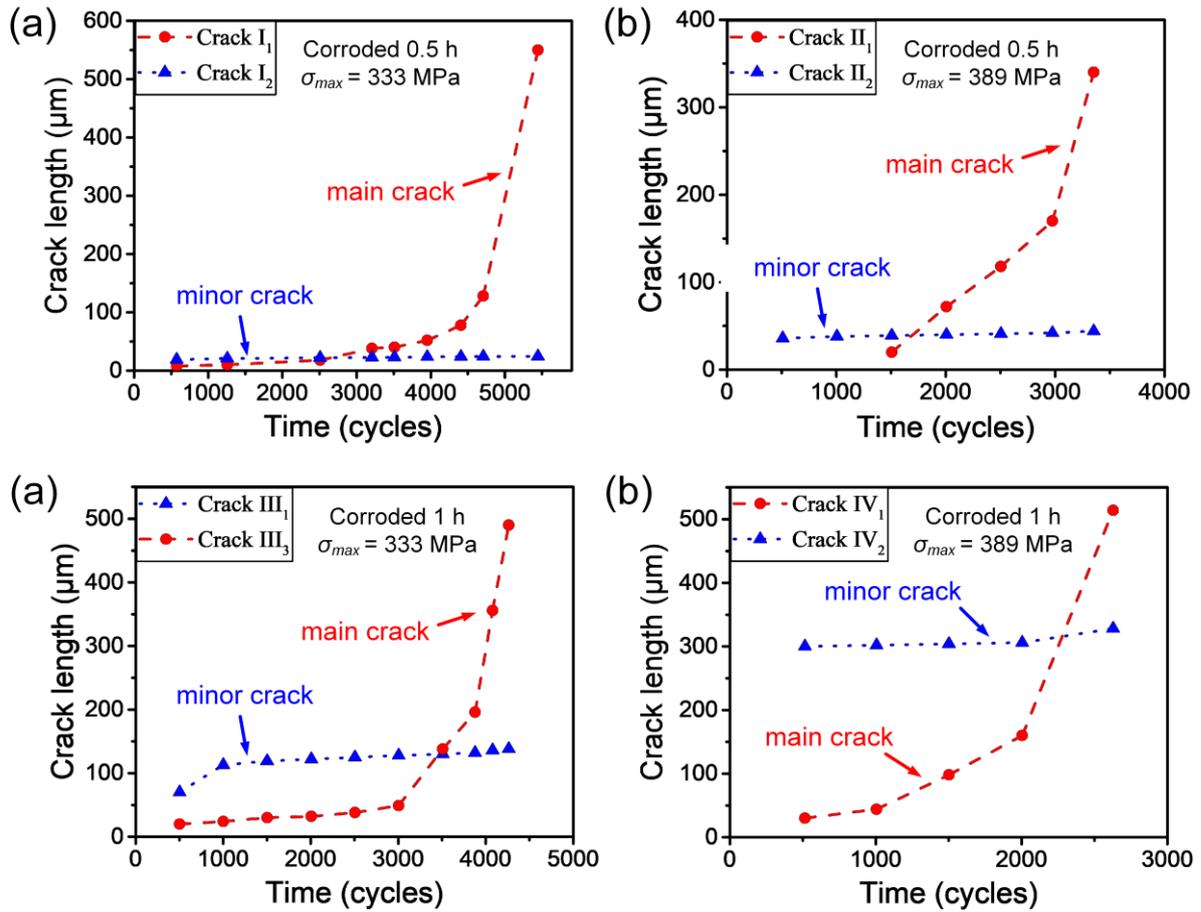
Fig. 12. Fatigue crack length curves of main crack (denoted by red line) and minor crack (denoted by blue line) versus fatigue cycle for different experimental conditions.
