Title	In-situ SEM study of fatigue micro-crack initiation and propagation behavior in pre-corroded AA7075-T7651
Author(s)	Song, Haipeng; Liu, Changchun; Zhang, Hao; Du, Juan; Yang, Xudong; Leen, Sean B.
Publication Date	2020-04-18
Publication Information	Song, Haipeng, Liu, Changchun, Zhang, Hao, Du, Juan, Yang, Xudong, & Leen, Sean B. (2020). In-situ SEM study of fatigue micro-crack initiation and propagation behavior in pre-corroded AA7075-T7651. International Journal of Fatigue, 137, 105655. doi: <a href="https://doi.org/10.1016/j.ijfatigue.2020.105655">https://doi.org/10.1016/j.ijfatigue.2020.105655</a>
Publisher	Elsevier
Link to publisher's version	<a href="https://doi.org/10.1016/j.ijfatigue.2020.105655">https://doi.org/10.1016/j.ijfatigue.2020.105655</a>

# ***In-situ* SEM study of fatigue micro-crack initiation and propagation behavior in pre-corroded AA7075-T7651**

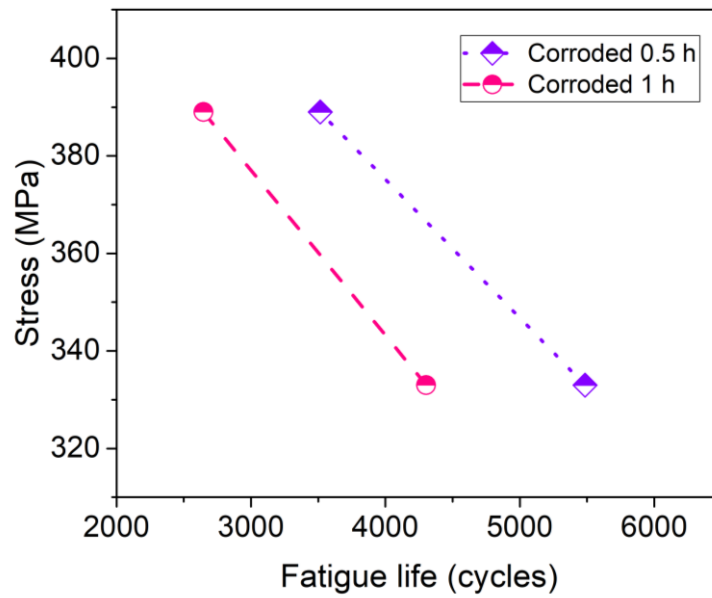
Fig. 3. Measured fatigue lives of pre-corroded AA7075-T7651 under different experimental conditions.

Fig. 3. Measured fatigue lives of pre-corroded AA7075-T7651 under different experimental conditions.

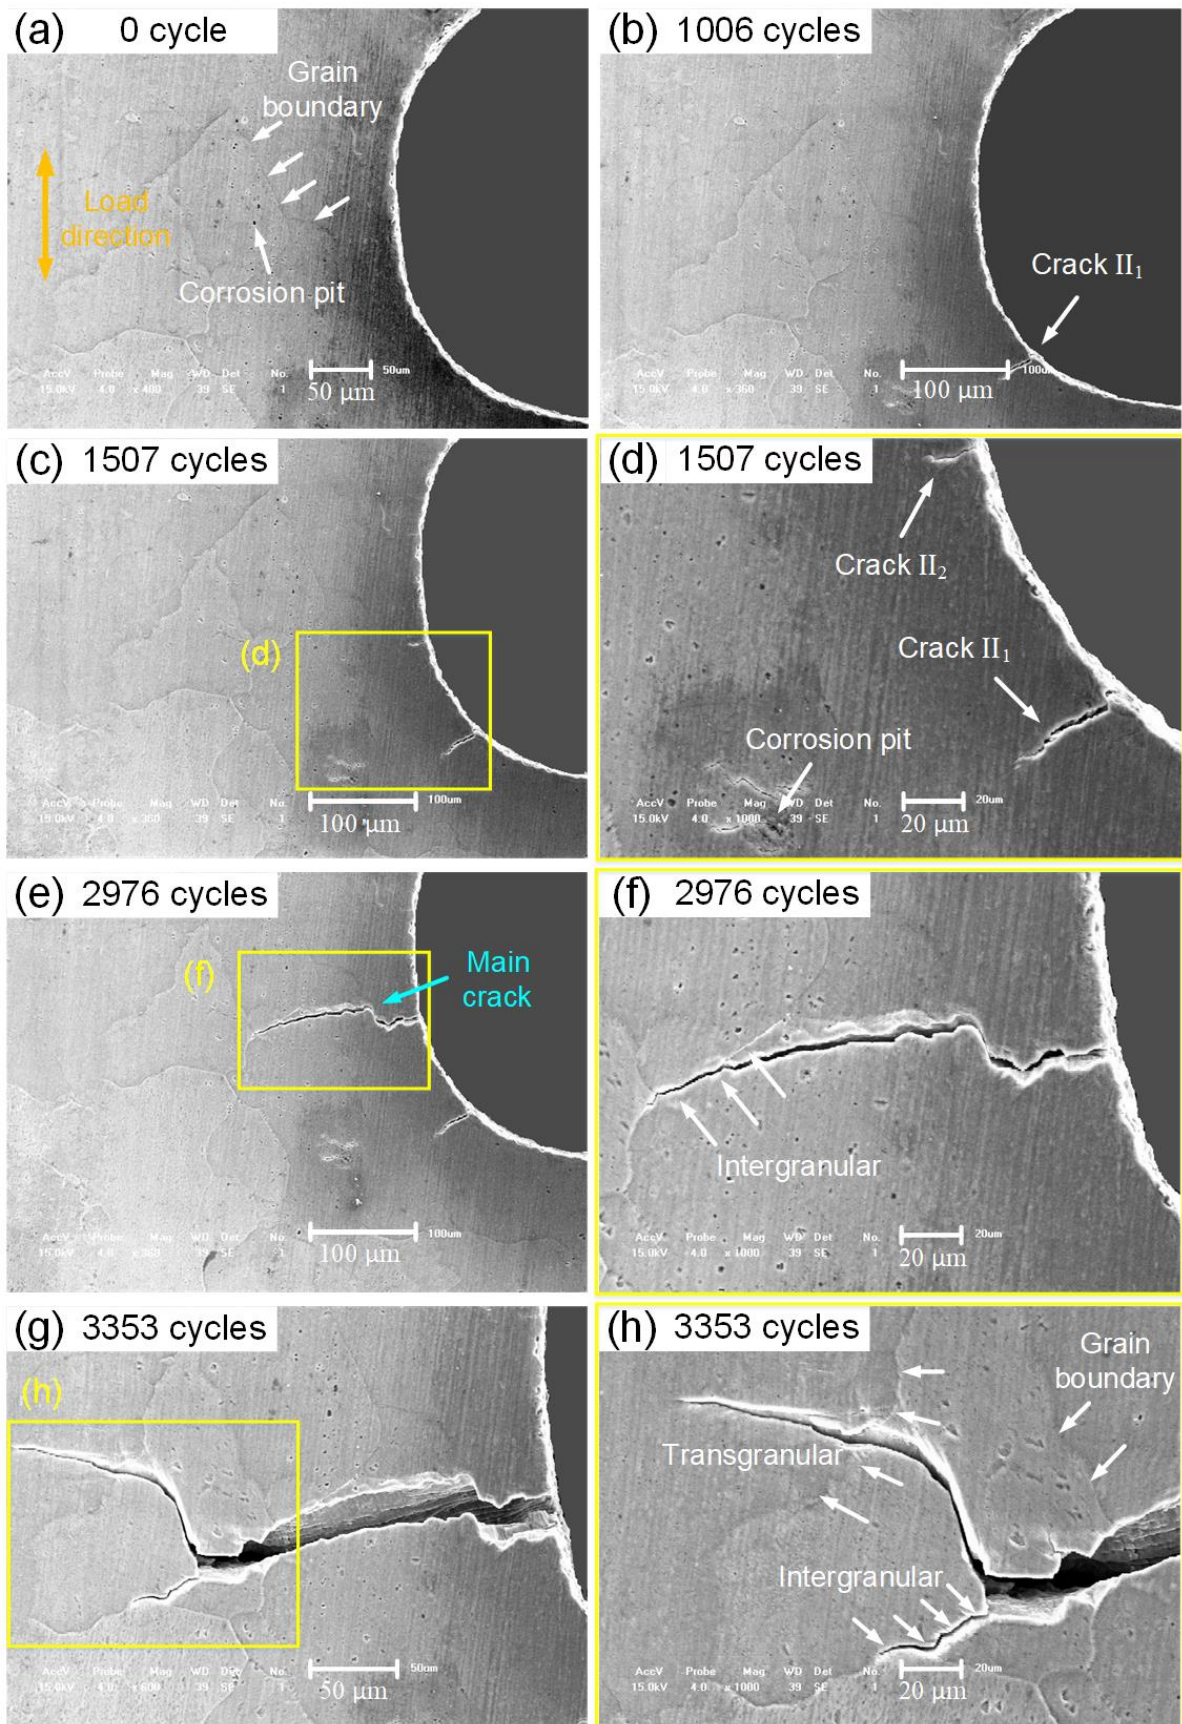
Fig. 5. *In-situ* SEM observation of fatigue failure process of specimen with a corrosion time of 0.5 hour, at a stress level of  $\sigma_{\max} = 389$  MPa; the yellow squares are the field of view of subsequent images.

Micro-crack arrest effects were also observed in the multiple crack propagation phenomena, attributed to decrease in driving force of crack propagation due to stress release caused by propagation of other cracks. The first crack initiated did not necessarily lead to final fracture. As shown in Fig. 5, crack II<sub>1</sub> arrested after initiation of main crack II<sub>2</sub>, indicating that propagation of the main crack had an inhibiting effect on secondary crack propagation. The lengths of main and secondary cracks for specimens under different experimental conditions were plotted versus numbers of fatigue cycles in Fig. 12, thus demonstrating that decreased propagation rate or arrest of secondary cracks after main crack initiation.

Fig. 5. *In-situ* SEM observation of fatigue failure process of specimen with a corrosion time of 0.5 hour, at a stress level of  $\sigma_{\max} = 389$  MPa; the yellow squares are the field of view of subsequent images.
