Design concepts for building products optimised for deconstruction

Innovative Design for the **Future** – **Use and Reuse of Wood (InFutUReWood)**

Deliverable Report *D3.3* of WP3

Report No.: NUIG-TERG-2022-02

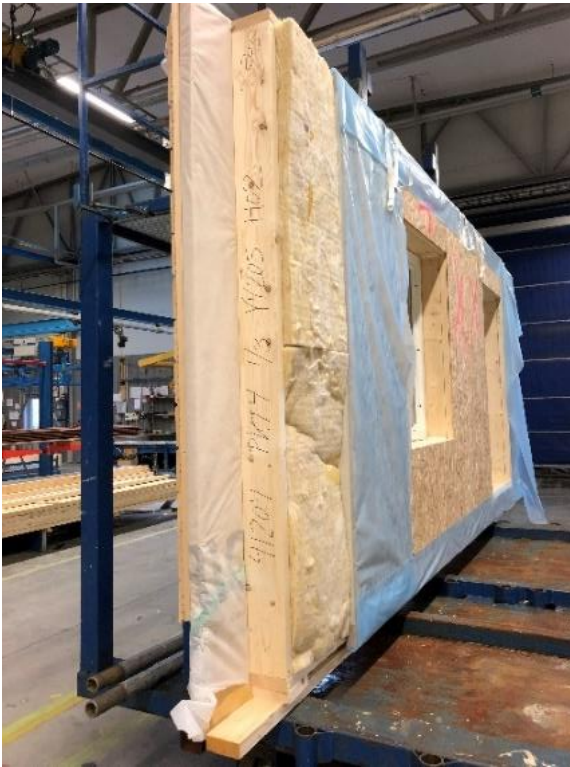
Figure 2-3: Derome Villa Anneberg wall panel loaded for transport at the manufacturing facility (image courtesy of Ylva Sandin).

Figure 2-3 shows the wall element loaded for transport at the manufacturing facility.

The current Derome practice is to transport the panels incomplete. A section of the internal OSB layer and internal batten and secondary insulation layer is omitted to expose the structural posts for screw-fixing on-site. The air-tightness plastic membrane is oversized and dressed back onto the internal OSB layer during transport. During the building assembly, the wall-panels are made airtight by overlapping and sealing the plastic membrane with an isoprene sealant and the omitted internal battens, additional internal insulation, and OSB are then fitted. The building is finished internally with a gypsum layer which is applied in-situ. Figure 2-4 to Figure 2-7 illustrate the current assembly steps of the semi-prefabricated wall panel. The diagrams are orientated top-down from outside to inside.

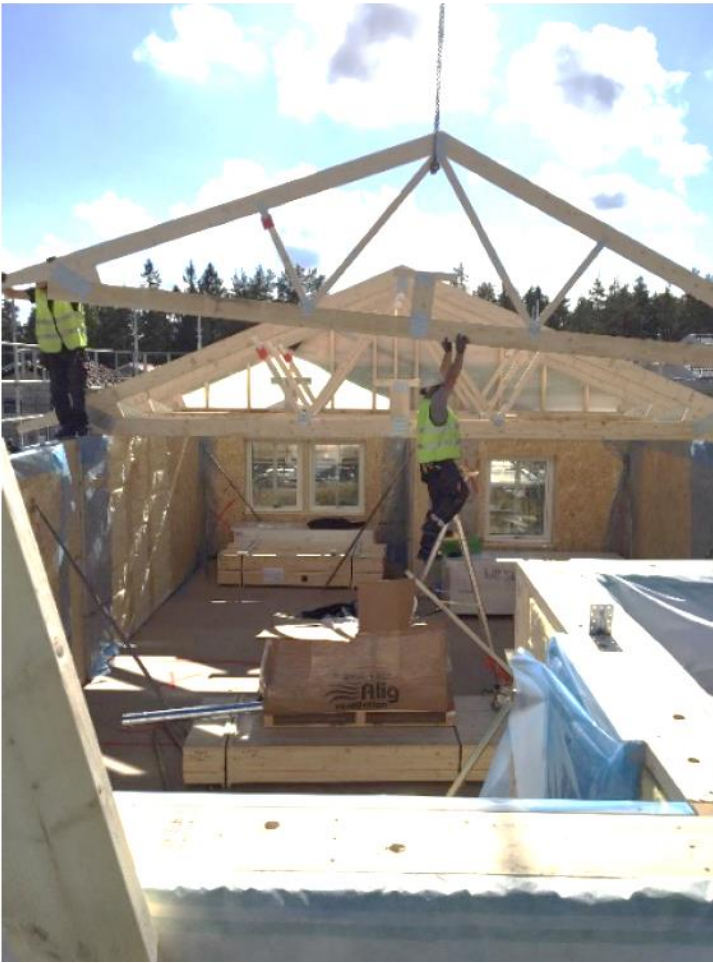
Figure 2-12: Derome roof truss lifted into position on site (image courtesy of Derome)

The roof trusses are lifted into place and screwed to the wall plate using angle-brackets and screws (Figure 2-12). During the disassembly of the reference Derome house additional fixings were found other than the prescribed angle-brackets connecting the roof to the walls. These connections were not included in the design/assembly drawings. The partial connection of the roof structure to the walls at unknown positions posed a hazard during the lifting of the roof at deconstruction. This practice also posed a risk of damage to both the roof and walls.

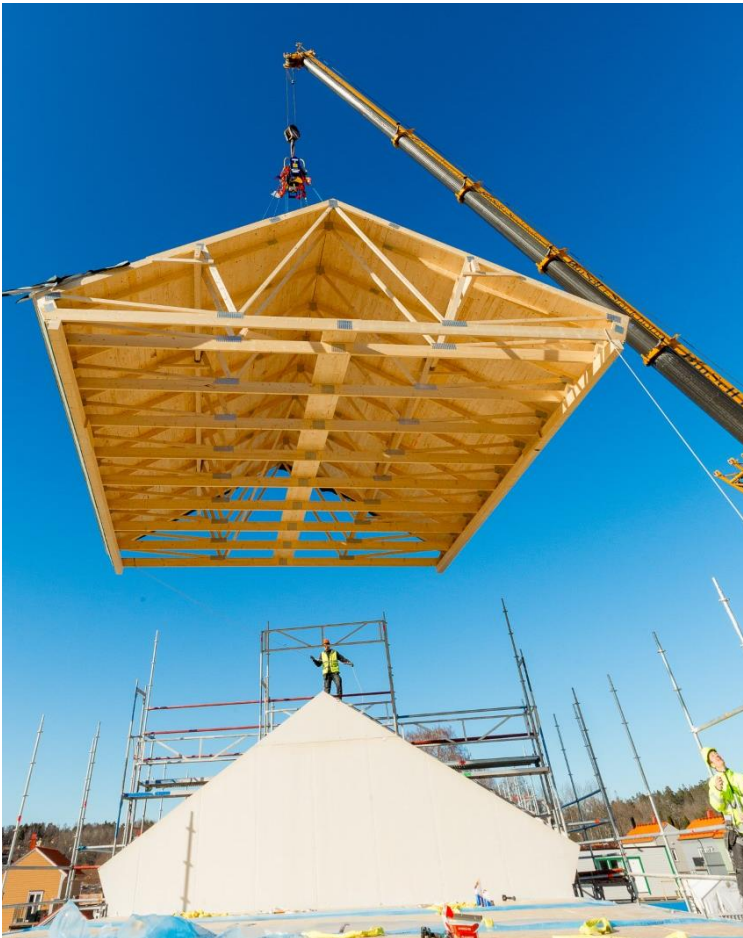
Figure 2-20: Derome roof structure lifted into position on site (image courtesy of Derome).

assembly of the roof structure on the ground before lifting into position as illustrated in Figure 2-20 would eliminate the need for temporary supports.

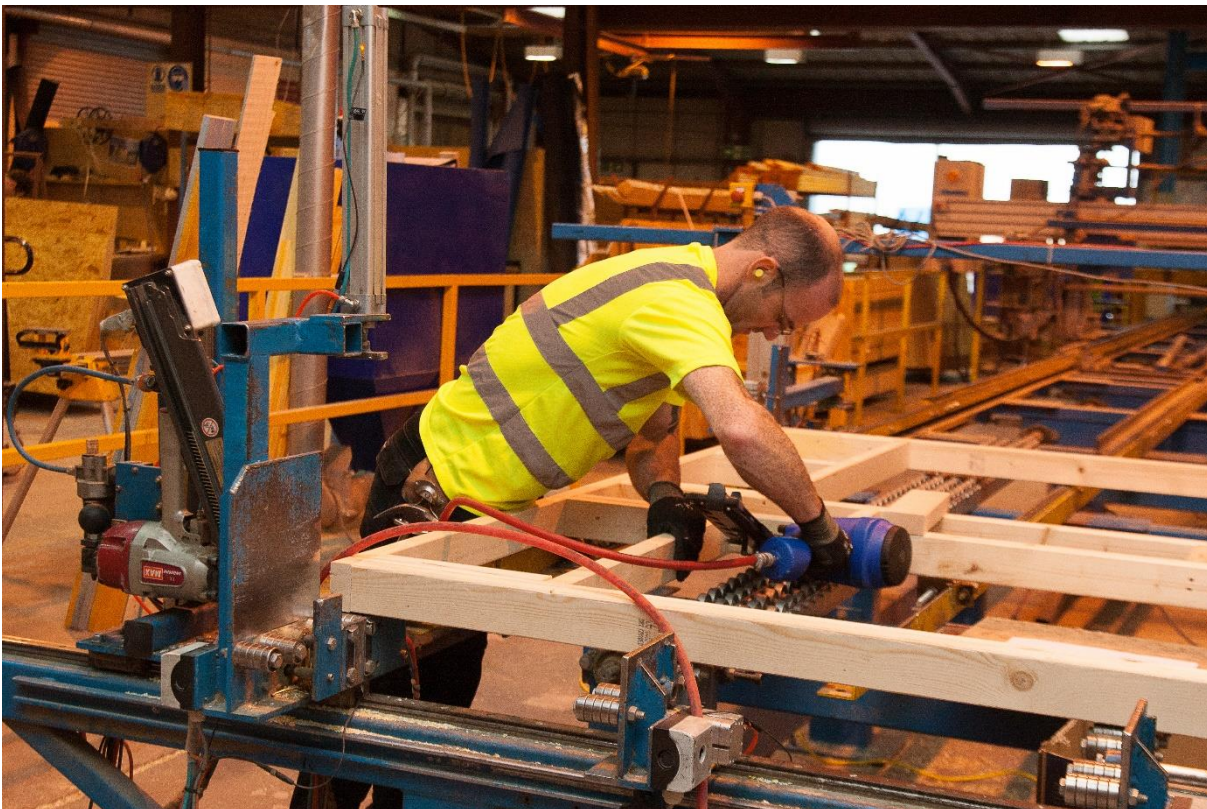
Figure 2-22: Panel assembly in Robertson Timber Engineering factory

All walls are mounted onto base plates, which are nailed to the ground floor concrete slab and to the floor cassettes on the first floor. The wall plates are deconstructed by sawing through the nailed connection between wall plate and wall panel, and it is expected that the wall plates are damaged in this process or during subsequent disassembly of the wall plate to floor connection.

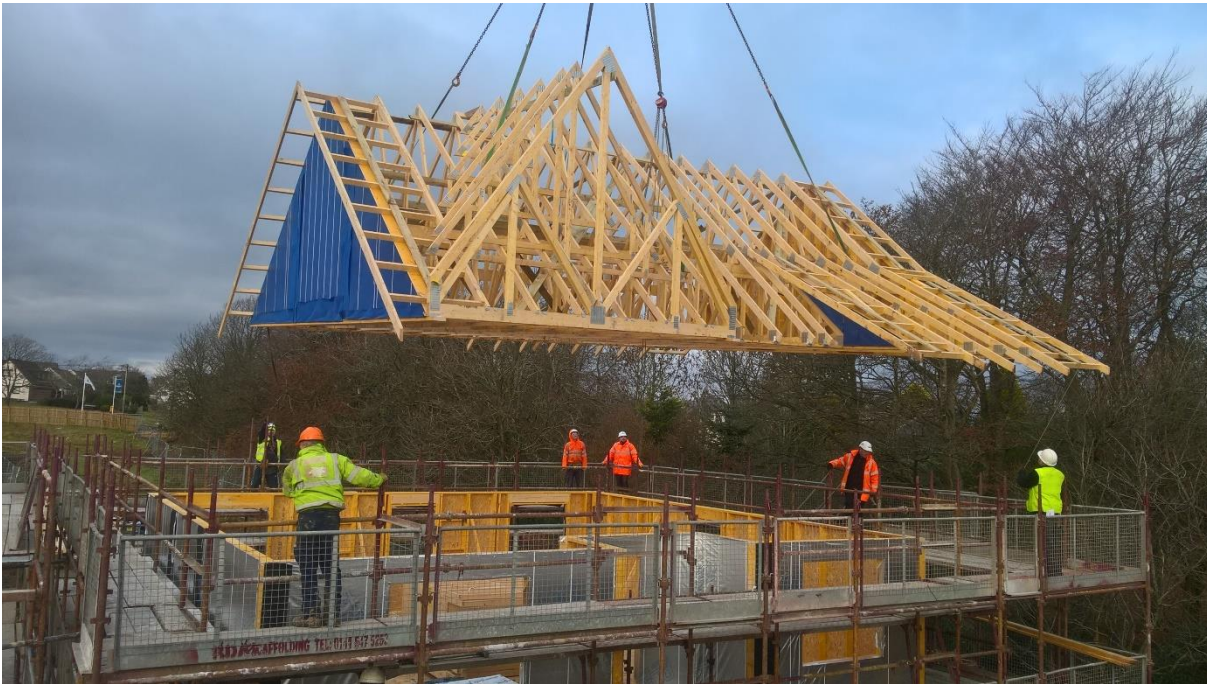
Figure 2-23: House roof structure lifted into position on Robertson site

It is expected that the timber roof structure can be moved and reused as one component. However, it may need to be divided to suit transportation load limits. It is expected that any damaged truss-clips can remain without causing any negative effect on the building. Replacement truss-clips can be provided adjacent to the original fixings.

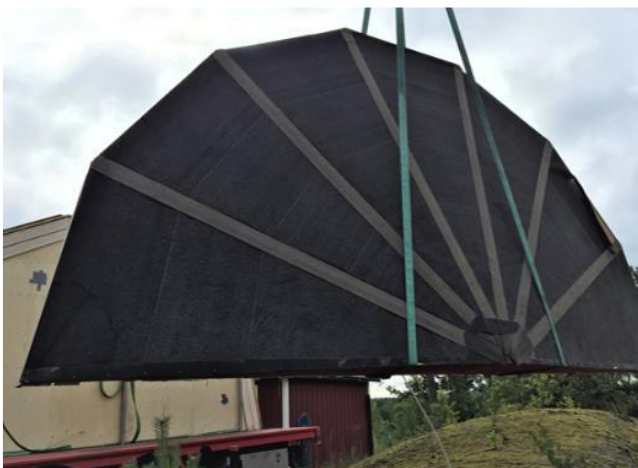
Figure 3-4: Magnolia Pavilion roof cassette demounted for transport in Tyresö, Sweden (image courtesy of IsoTimber).

The building was successfully deconstructed and reassembled in Segeltorp, Sweden without any significant waste. Figure 3-4 and Figure 3-5 show the roof cassettes demounted and crane-lifted into place after transport.
